**LAKE FOREST DAM,
STE. GENEVIEVE COUNTY, MISSOURI,
MO 30087**

PHASE 1 INSPECTION REPORT NATIONAL DAM SAFETY PROGRAM

LAKE FOREST DAM
STE. GENEVIEVE COUNTY, MISSOURI

PHASE I INSPECTION REPORT
NATIONAL DAM SAFETY PROGRAM
LAKE FOREST DAM - ID NO. 30087

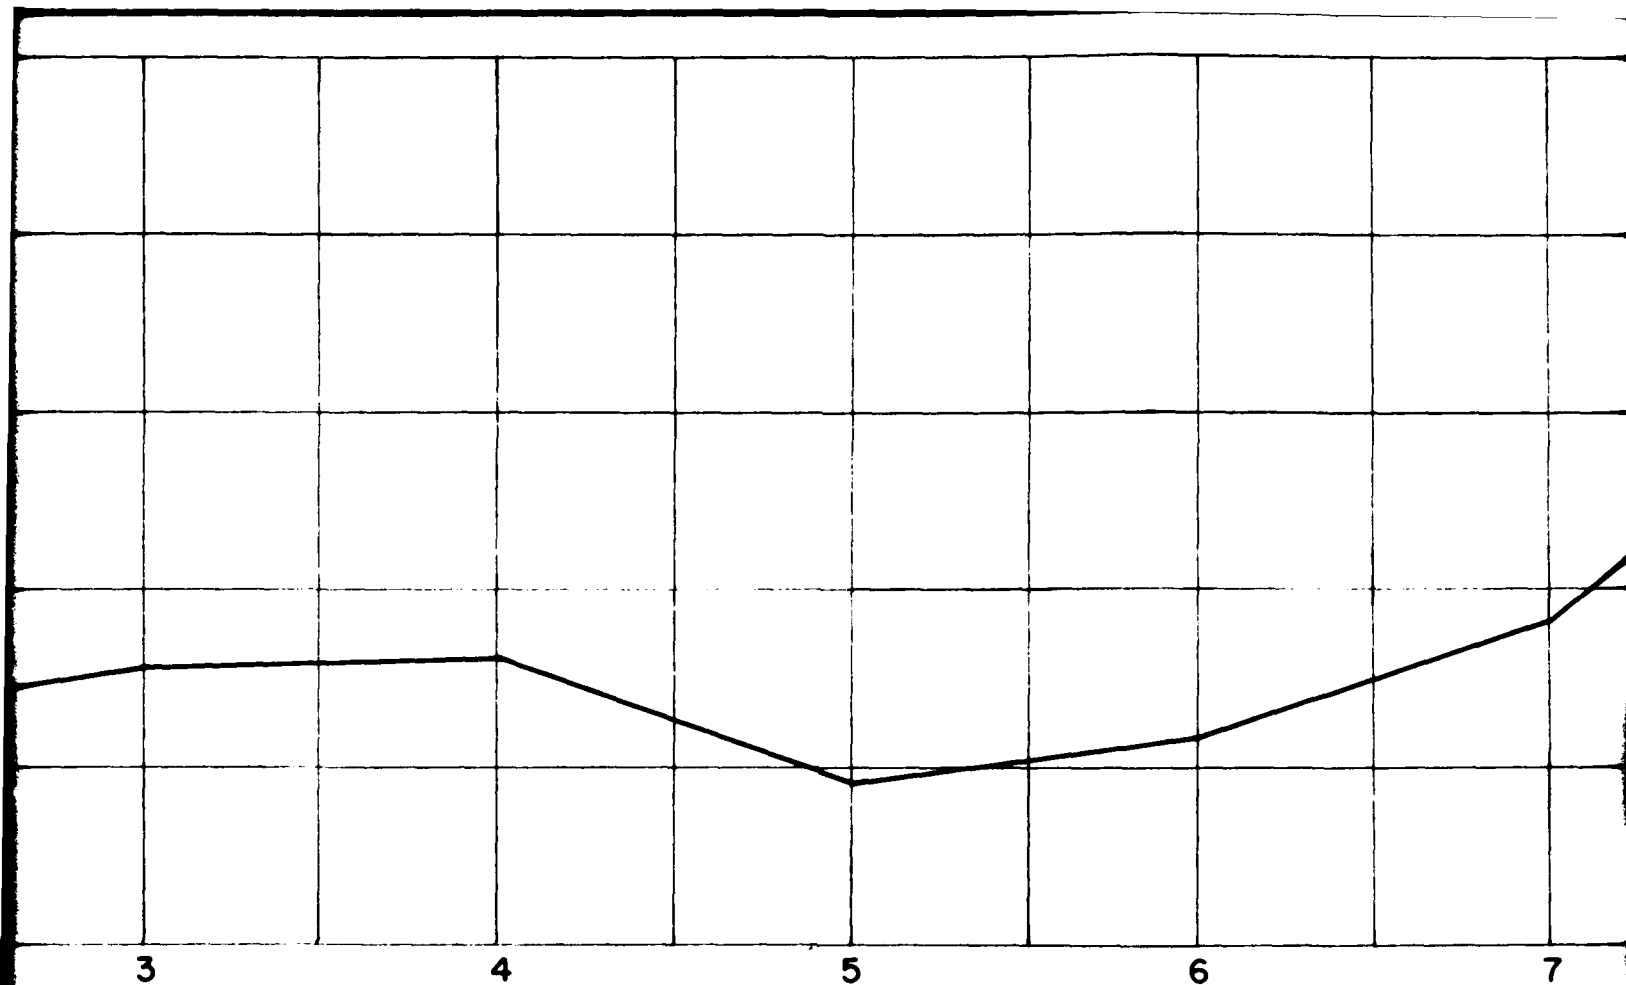
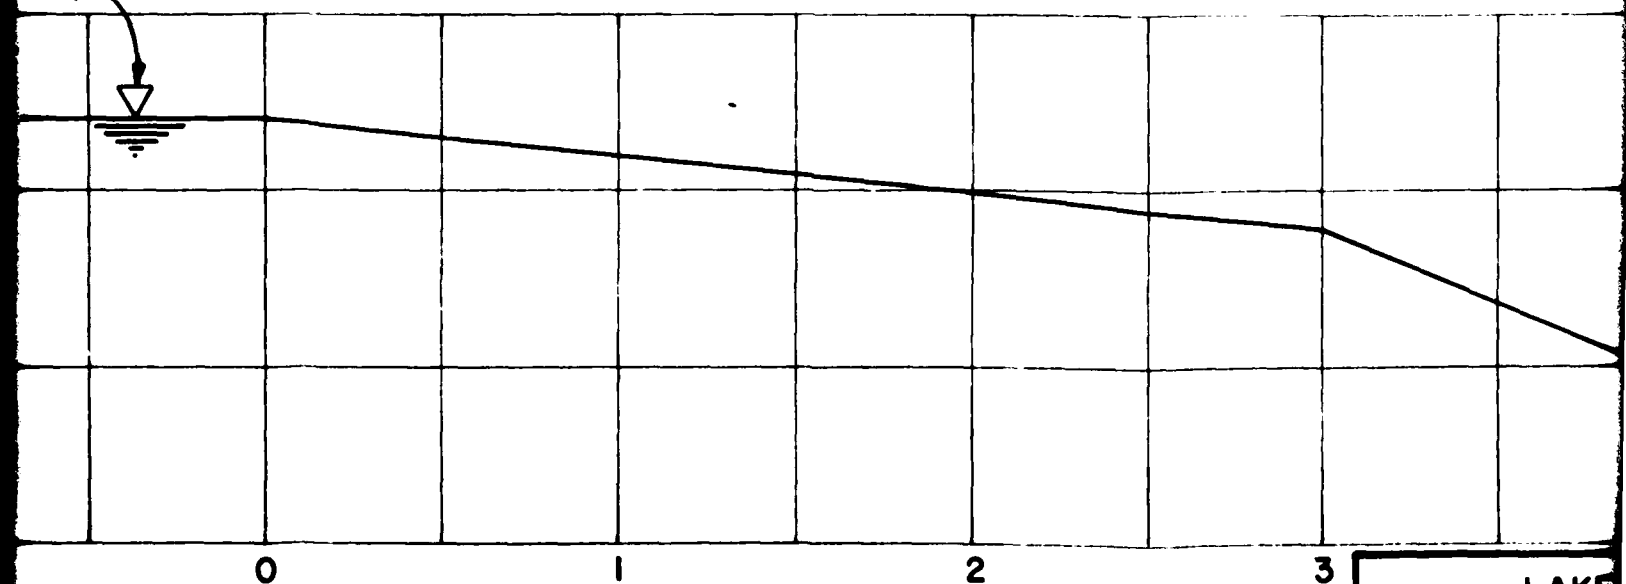
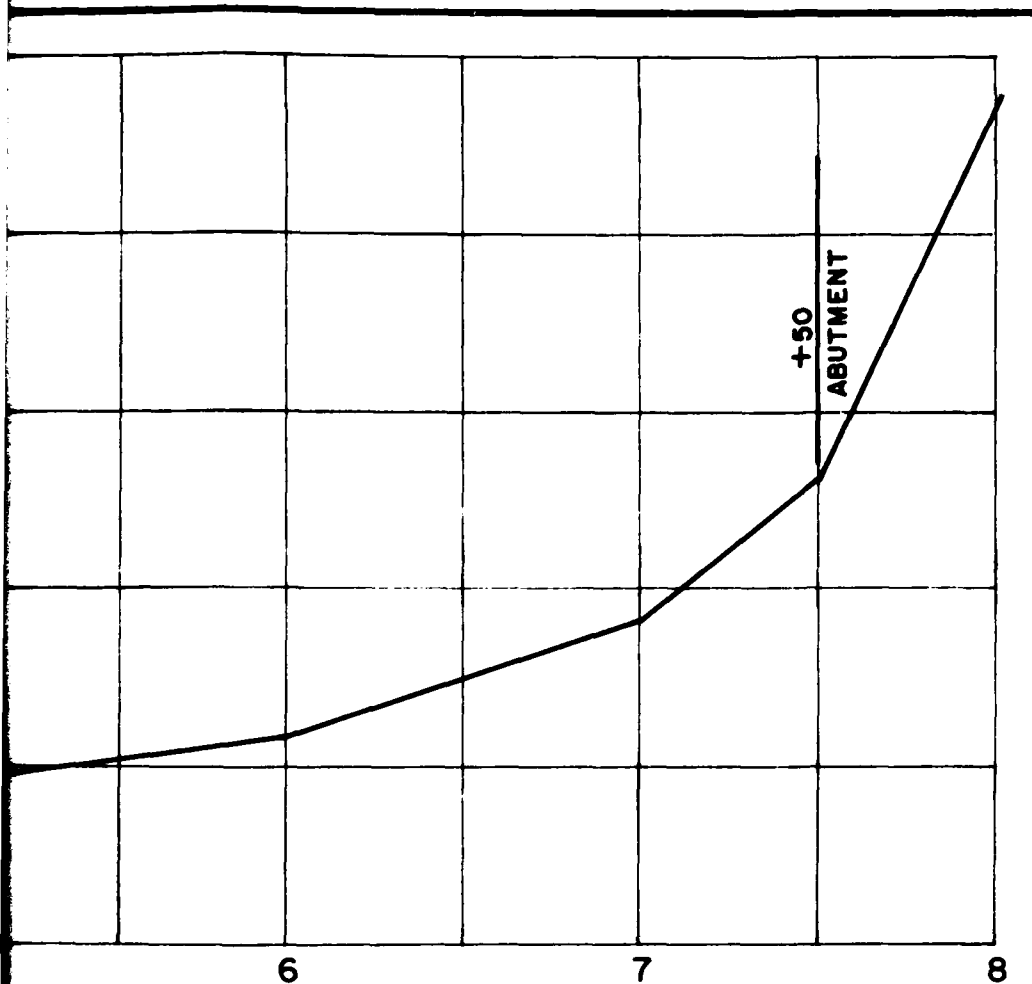
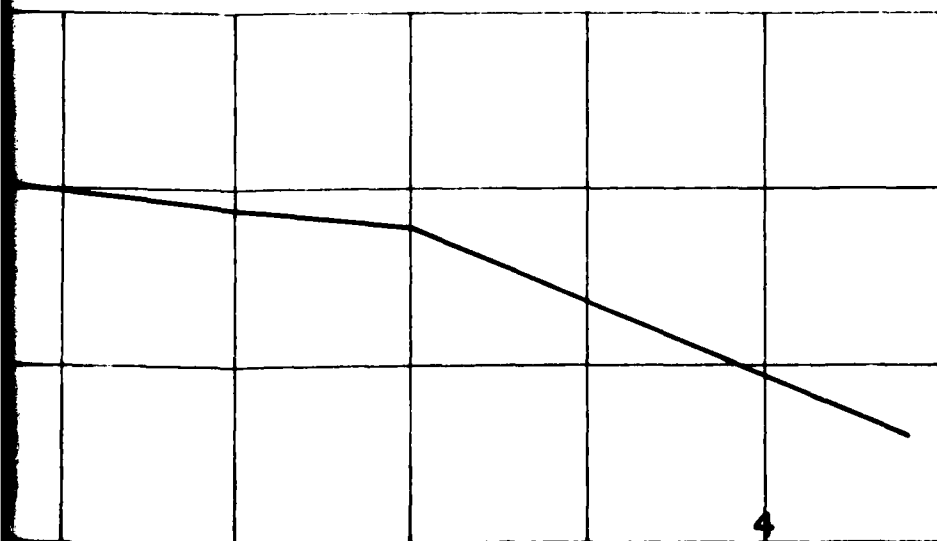
LAKE FOREST
DAM & SPILLWAY PROFILES
Horner & Shifrin, Inc. Oct. 1978

The crest of the dam was found to be approximately 5 feet lower at a point near the center of the dam than in the area adjacent to the spillway. (The low point of the dam is approximately 9 feet higher than the spillway crest.) As a result, the capacity of the spillway to discharge lake outflow without overtopping the dam is reduced. According to the criteria set forth in the recommended guidelines (see text) the minimum spillway design flood for this dam, which is classified as intermediate in size and of high hazard potential, is specified to be the Probable Maximum Flood (PMF). PMF is the flood that may be expected from the most severe combination of critical meteorologic and hydrologic conditions that are reasonably possible in the region. Results of a hydrologic/hydraulic analysis indicated that the existing spillway is inadequate to pass the lake outflow resulting from a storm of PMF magnitude. It is capable of passing the lake outflow resulting from the 1 percent chance (100-year frequency) flood. The spillway is capable of passing lake outflow corresponding to approximately 22 percent of the PMF without overtopping the dam. The length of the downstream damage zone, should failure of the dam occur, is estimated to be ten miles. There are at least two houses and one bridge crossing within the first two miles downstream of the dam.

c. Spillway. The spillway is cut into rock (see Photo 6) at the left abutment. The control elevation of the spillway is approximately nine feet lower than the low point of the dam. A profile of the dam crest centerline extending through the spillway is shown on Plate 3. A concrete bridge (see Photos 5 and 7) spans the spillway channel along the alignment of the dam. The spillway channel joins Big Bottom Creek approximately 450 feet downstream of the dam. A series of rock falls is located in the spillway channel just upstream of the junction with the original stream. A profile along the spillway channel centerline through the control section is shown on Plate 3.

(1) Based upon criteria set forth in the recommended guidelines, alterations should be made to the design of the dam in order to pass lake outflow resulting from a storm of at least probable maximum flood magnitude.
